## Public access re-design observation summary

In 2012, Hennepin County piloted a project to re-design the North Arm public access on Lake Minnetonka using theories from behavior change research to prompt boaters to take proper aquatic invasive species (AIS) prevention actions. Based on the success of this pilot and the development of new technology, the county expanded accesses re-design at Spring Park, Lake Minnetonka and Long Lake public accesses.

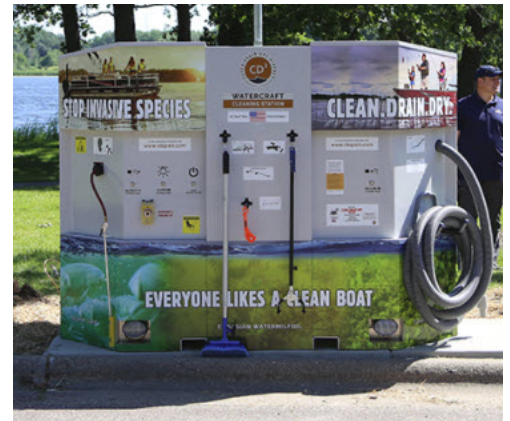
CD3 waterless cleaning system

The county's current behavior change strategies include: the CD3 waterless cleaning system, which provides the tools to facilitate the actions; pavement markings to influence traffic flow, designated locations to take AIS prevention measures; and signs to prompt the desired behaviors. Using this full complement of behavior change strategies, the county re-designed the access at Spring Park starting in 2016 (completed in 2018) and at Long Lake in 2018.

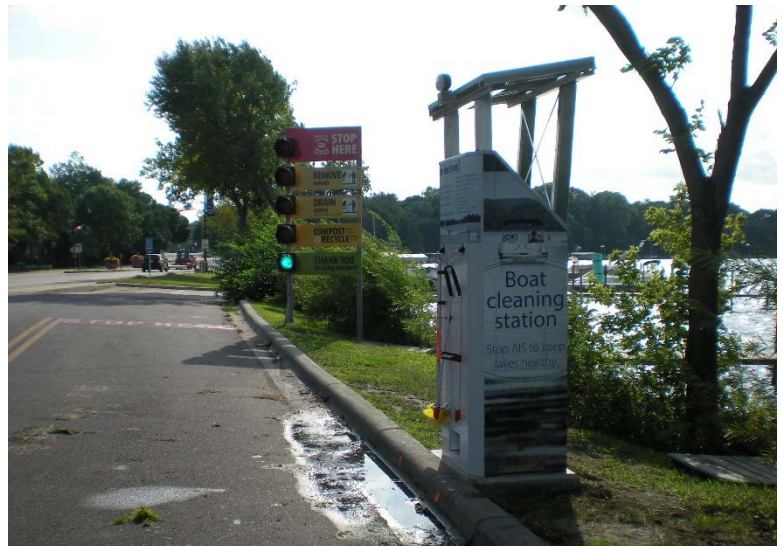
*CD3 outpost and prompt signs*

The changes to the traffic flow using stop bar markings and simple instruction signs serve as prompts to remind people to take the appropriate action and can help overcome the issue of boaters operating on auto-pilot as they complete the tasks to launch their watercraft. At the Spring Park access in 2018, observers found that 87 percent of boaters followed the traffic markings and stop bars when entering and exiting.

It is also interesting to note that the full benefits of the redesigned access may take a few years to be realized. Compliance and self-inspection rates have improved at Spring Park between 2017 and 2018. Note that two additional CD3 outposts were added in 2018. The county will continue to gather observation data in 2019 to better understand the changes in behavior over time.

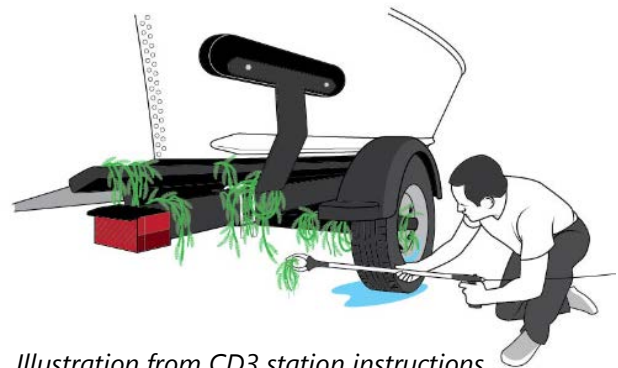
*Illustration from CD3 station instructions  
Image courtesy of CD3*

There are significant differences in county accesses and watercraft that boaters launch. This appears to create differences in which CD3 tools are used. As new tools are invented, accurate data can be gathered to target the tools for each specific access condition and user preferences. For example, a longer grabber tool and the current grabber tool could be installed at a Lake Minnetonka CD3 station. The CD3 tool monitoring data would help to determine which grabber tool is preferred, assuming that the larger boats may prefer the longer tool. Another example, at Long Lake in 2018, the percentage use of the vacuum plus air blower was greater than 50 percent of all tool use. At Spring Park, the vacuum and air blower accounts for less than 18 percent and the grabber tool alone accounts for about half of all tool uses. This may be attributed by Spring Park observation description of "weedy" 88 percent of the time and Long Lake only 14 percent.
