Assessing the Risk of AIS in Waters with no Public Boat Access

Hennepin County 2018-2019

Fortin Consulting, Inc.
February 2020

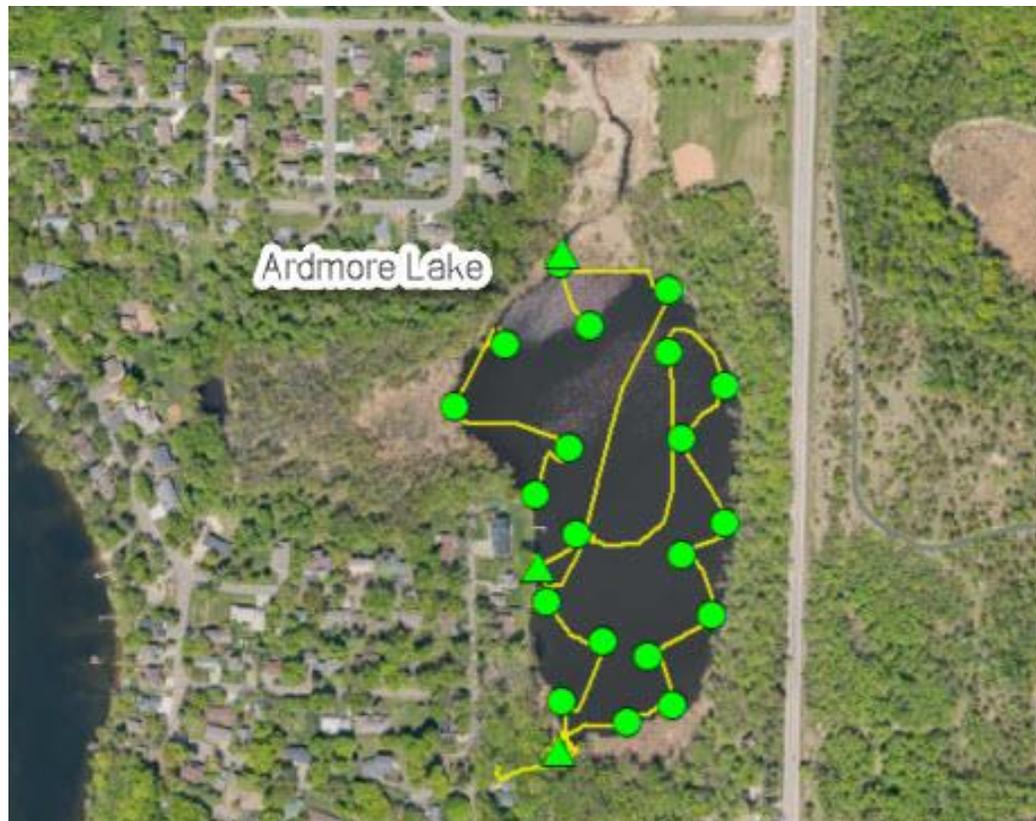
Invasive carp were seen on the lake and were noted by a property owner on the lake. No invasive aquatic vegetation was found but Reed Canary Grass populations were present on the shore. The invasive carp could have been introduced by property owners or entered through the stream connection on the north end of the lake.

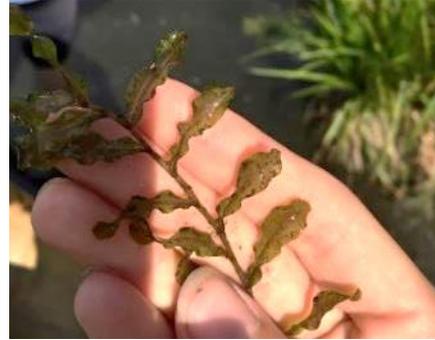
Curly-leaf pondweed on Birch Island Lake

Purple loosestrife and reed canary grass were found scattered on the shoreline of Birch Island Lake, never occurring more densely than cattail. Curly-leaf pondweed was found at the camp canoe launch location near a dilapidated dock.

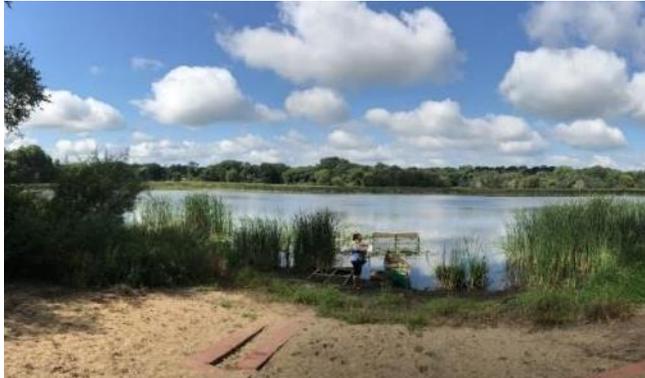
Canoe launch used by Camp Eden Wood at Birch Island Lake

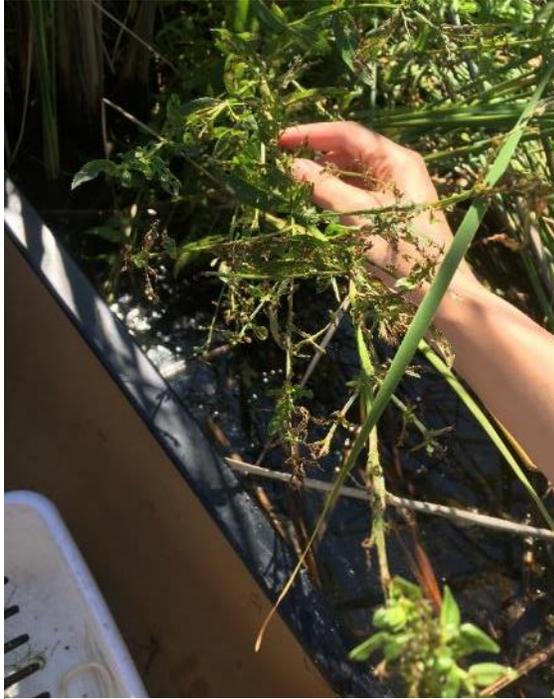
Purple loosestrife at Lake Classen

No submerged AIS were found at Lake Classen, only Purple Loosestrife and Reed Canary Grass. Both were not commonly seen on the shore that was dominated by Cattail. Orono High School is next to the lake and a walking path leads to the shore.

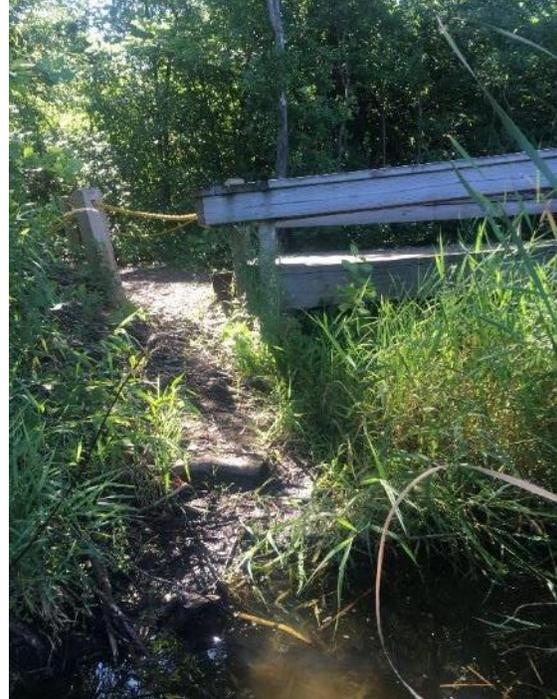
Reed canary grass at walking path near lake

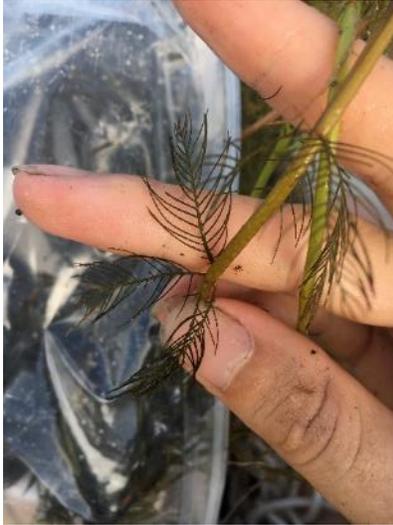
Eurasian watermilfoil in General Mills pond

Curly-leaf pondweed and Eurasian watermilfoil were present. Both were found as a single plant at only two sample locations. Purple loosestrife and Reed Canary Grass were also observed but not as the dominate shoreline plants. Basset Creek flows downstream from Lake Independence along the southern side of the wetland. The wetland is in a nature preserve and is surrounded by a trail system.

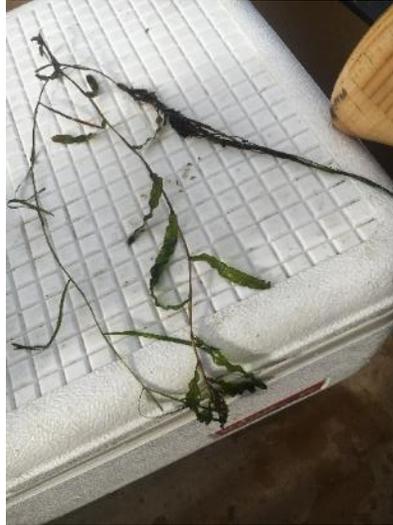
Curly-leaf pondweed in General Mills pond

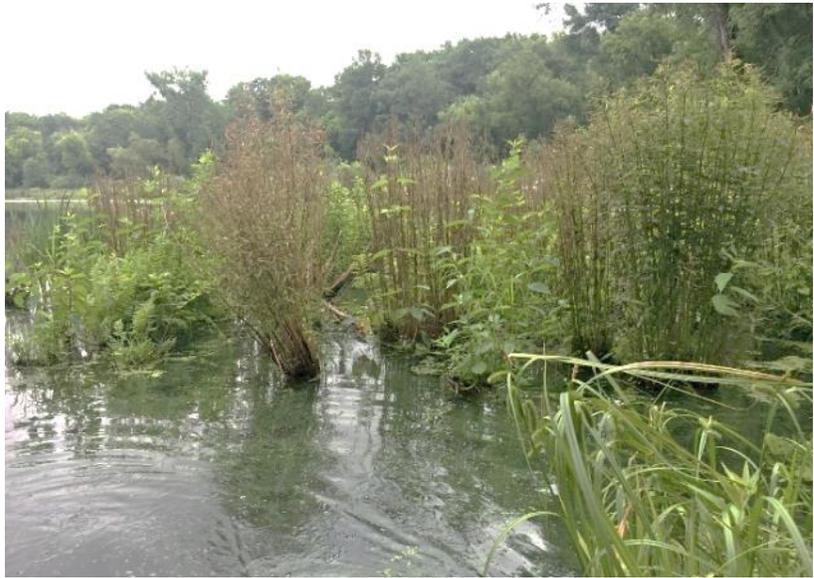
Damaged purple loosestrife in Hadley Lake

Purple loosestrife, curly-leaf pondweed, and reed canary grass were found in Hadley Lake. The purple loosestrife was dense and was present in about half of the samples. The purple loosestrife had a population of *Galerucella* beetles on it, and plant damage from the beetle feeding was observed. Reed canary grass was found less frequently than purple loosestrife. Curly-leaf pondweed was present in half the samples. It was often decaying, and a homeowner noted that the lake association had treated the lake.

There were also signs stating the lake was treated on June 11.

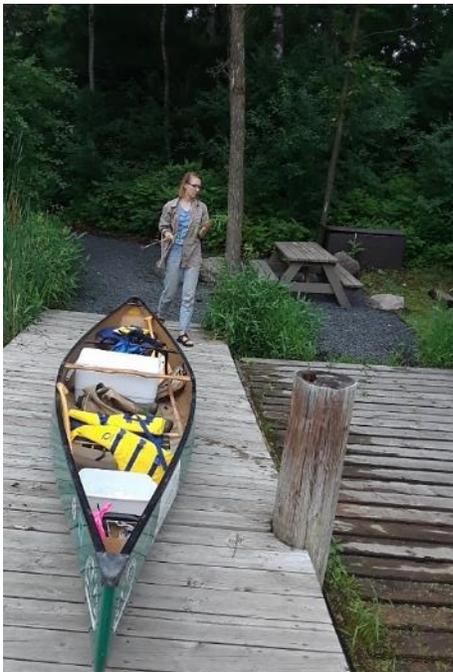
Private park and lake entrance for Residents on Hadley Lake

Hadley Lake has a private park, known as Rusten Woods, for homeowners on the lake. There is a private canoe launch and several canoes were observed nearby.

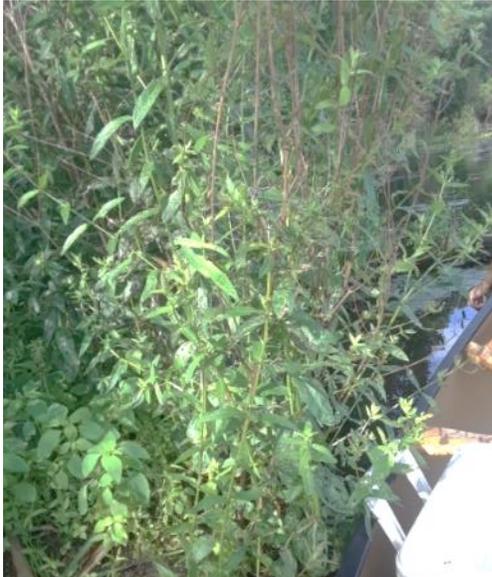
Purple loosestrife on Lake Hannon

Purple loosestrife and Chinese mystery snail (CMS) were present on Hannan Lake. Purple loosestrife was present in seven of the samples and was generally spotted in clusters or densely along the shoreline. A Chinese mystery snail shell was found near the canoe launch point.

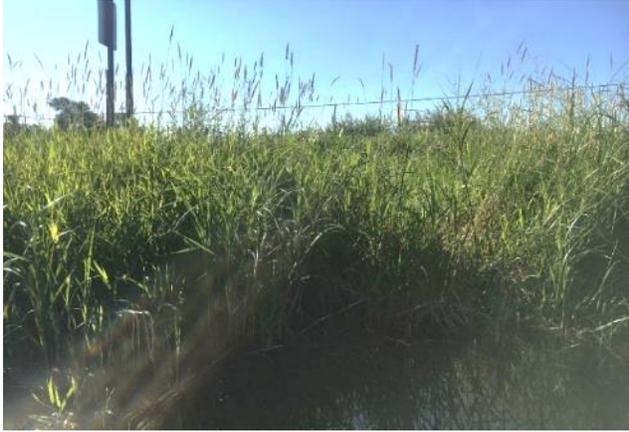
Reed canary grass on Lake Henry

Henry Lake had curly-leaf pondweed and reed canary grass present. Reed canary grass was the dominant shoreline plant in four samples. Curly-leaf pondweed was present in about half of the samples.

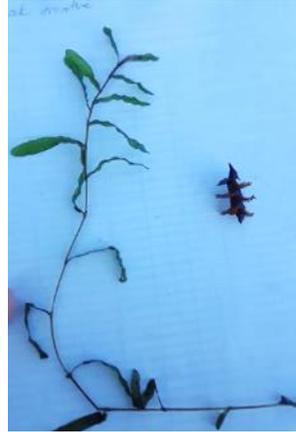
Curly-leaf pondweed on Lake Henry

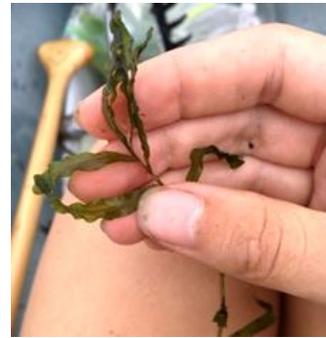
Curly-leaf pondweed on Jubert Lake

Curly-leaf pondweed was found on Jubert Lake. The lake was surveyed in late August after the plants usually die off. Only one vegetation sample was found but on parts of the lake numerous turions were found on top of lily pads. A homeowner also described what sounded like Curly-leaf pondweed; large mats of vegetation that take over the lake in early summer and die off in July. The number of turions seen above the water and the description from the homeowner suggest Curly-leaf pondweed is the dominant species in the lake in early summer. The homeowner stated that there was a fish kill in the spring of 2018 that included carp. No carp were seen by FCI, and the lake isn't listed as infested by carp.

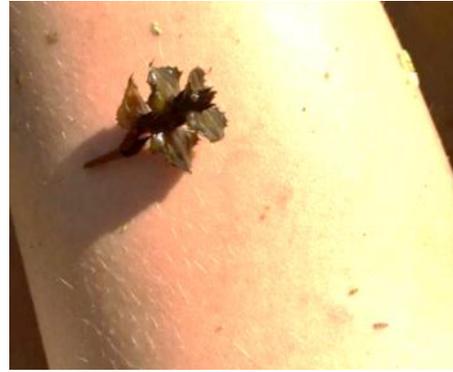
Curly-leaf pondweed turion from Loring Pond

A curly-leaf pondweed turion was found by FCI. Eurasian watermilfoil, Chinese mystery snail, and goldfish have also been reported on the lake by the Minneapolis Park & Recreation Board (MPRB) and on the DNR Lake Finder but were not observed during the survey. While only one turion was found it is likely that the density is higher during peak curly-leaf pondweed season.

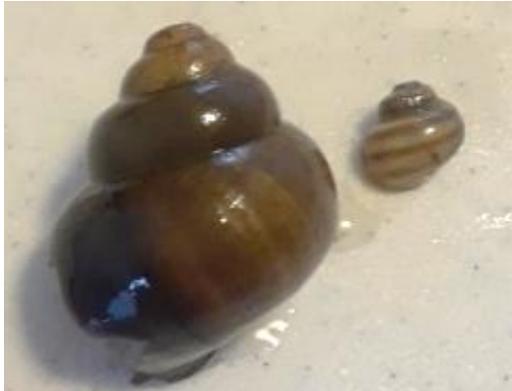
Chinese and banded mystery snails- Magda Lake

Curly-leaf pondweed, Chinese mystery snail, and banded mystery snail were found on Magda Lake. Eurasian watermilfoil was previously recorded and was observed later in the year. Purple loosestrife has been found on the lake in previous years. Curly-leaf pondweed occurred in almost every sample. Chinese mystery snail shells were seen at multiple sample sites and one banded mystery snail shell was found. The invasive species were observed

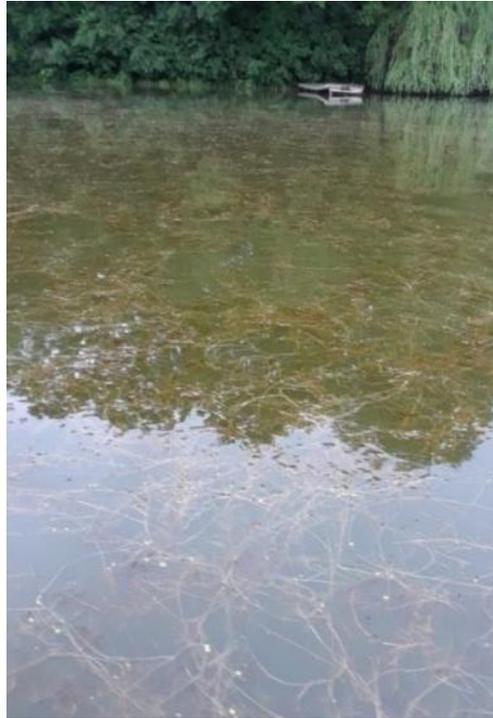
Curly-leaf pondweed in Magda Lake

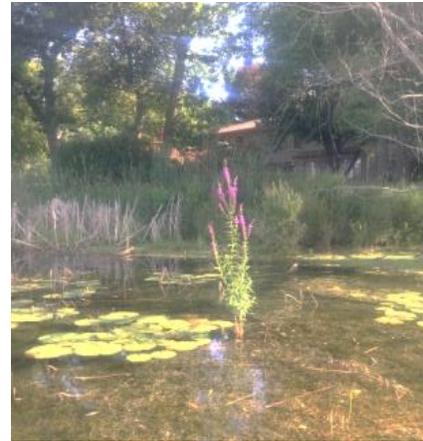
Purple loosestrife: N. Anderson Lake

Purple loosestrife, Chinese mystery snail, and reed canary grass were found by FCI while surveying the lake. Eurasian watermilfoil and Curly-leaf pondweed are also present according to Three Rivers Parks District. Reed canary grass and purple loosestrife occurred in about five of the samples as either the dominant species or in patches. Chinese mystery snail shells were observed in over half of all samples and usually in multiples.

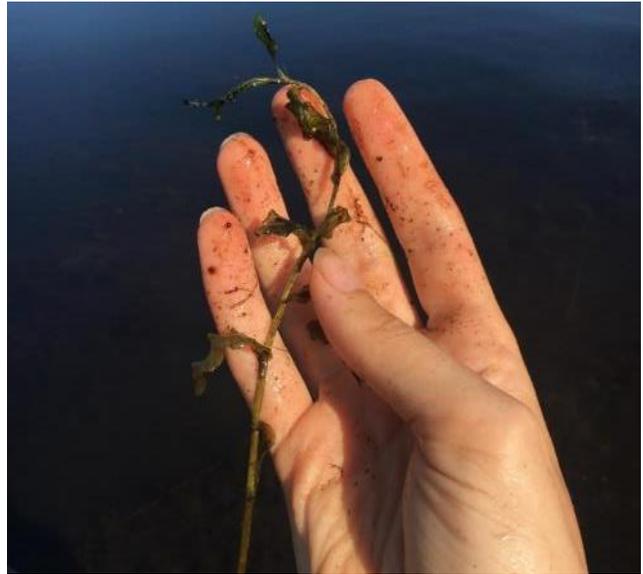
Curly-leaf pondweed was frequently seen on Ox Yoke Lake and is likely more frequent earlier in the summer. Invasive carp was seen on the lake in two spots. Reed Canary Grass was observed but infrequently. The lake is downstream from Independence and Robina lakes and had a few residences with private docks.

Curly-leaf pondweed in Ox Yoke Lake

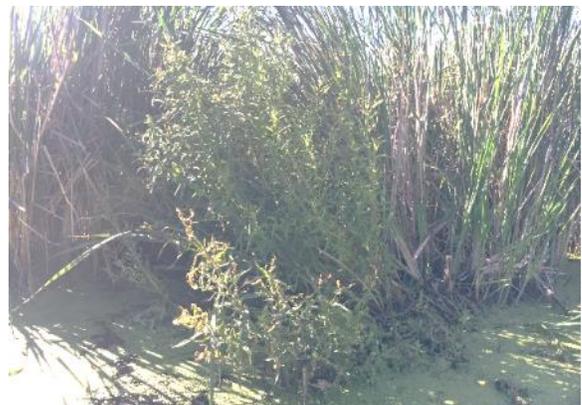
Purple loosestrife on Palmer Lake

Purple loosestrife, curly-leaf pondweed, Chinese mystery snail, reed canary grass, and carp were found in Palmer Lake. Curly-leaf pondweed occurred in about half of the samples. Purple loosestrife, reed canary grass, and Chinese mystery snail were each observed once on the lake. Carp were seen at a few sample sites on the lake and Wenck staff were doing a fisheries survey and confirmed the presence of invasive carp on the lake.

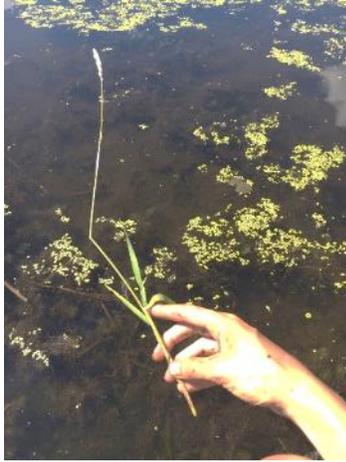
Reed canary grass on Palmer Lake

Purple loosestrife and Reed canary grass were likely spread by seed by water, wind, animals, or people. Chinese mystery snail and curly-leaf pondweed were possibly introduced by people using private docks or upstream waters. Invasive carp was likely introduced as from upstream waters.

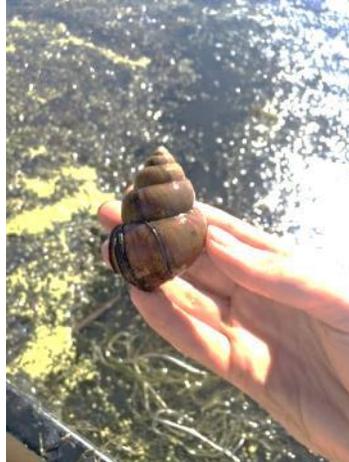
Chinese mystery snail on Palmer

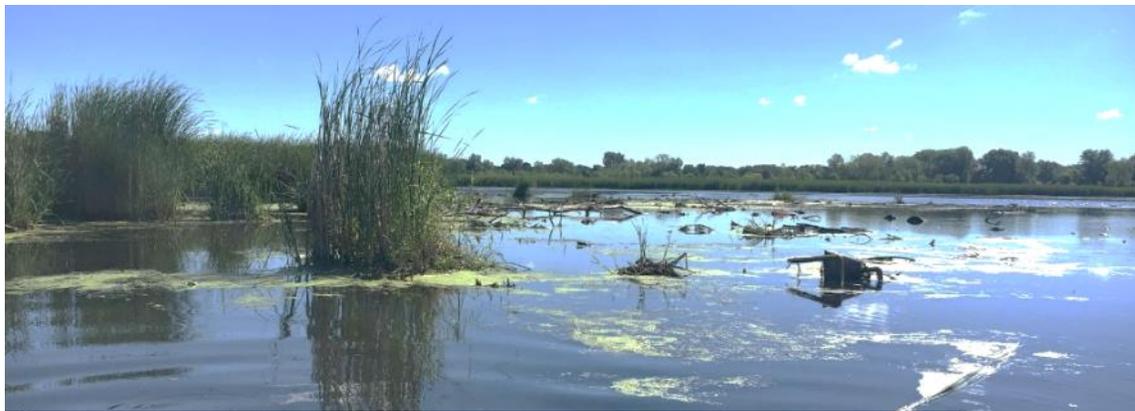
Palmer Lake was surveyed on July 17, 2018. The lake is shallow and thick with vegetation on the west side. The east side had less vegetation. There was a lot of visible trash where Shingle Creek comes into the lake. The dominant species were cattail, coontail, and sago pondweed (*Stuckenia pectinata*).

Convergence of Shingle Creek and Palmer Lake

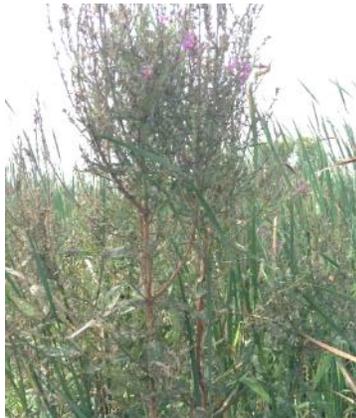
Purple loosestrife on Lake Robina

Purple loosestrife, curly-leaf pondweed, and reed canary grass were found on Lake Robina. Purple loosestrife was present at most sample sites on the lake and usually seen in patches or as the dominant species on the shoreline. Reed canary grass was observed as occurring densely at three sample sites.

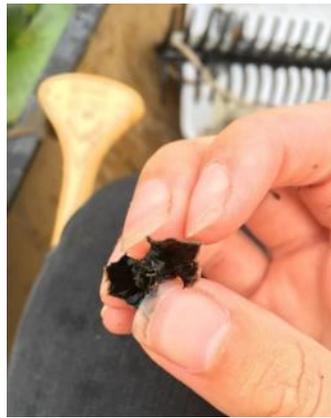
Curly-leaf pondweed turion on Lake Robina

One curly-leaf pondweed turion was observed on the lake. Robina was surveyed in September, so it is likely curly-leaf pondweed is more dominant earlier in the season.
